Nearest tower in view: NA Figure 4.14-20a **Existing Conditions** from Key Observation Point 16 Lake Pleasant Regional Park Campground looking southwest Sun Valley to Morgan 500/230kV Transmission Line EIS Project

Simulation of Proposed Action and Alternative 2 from Key Observation Point 16 Lake Pleasant Regional Park Campground looking southwest

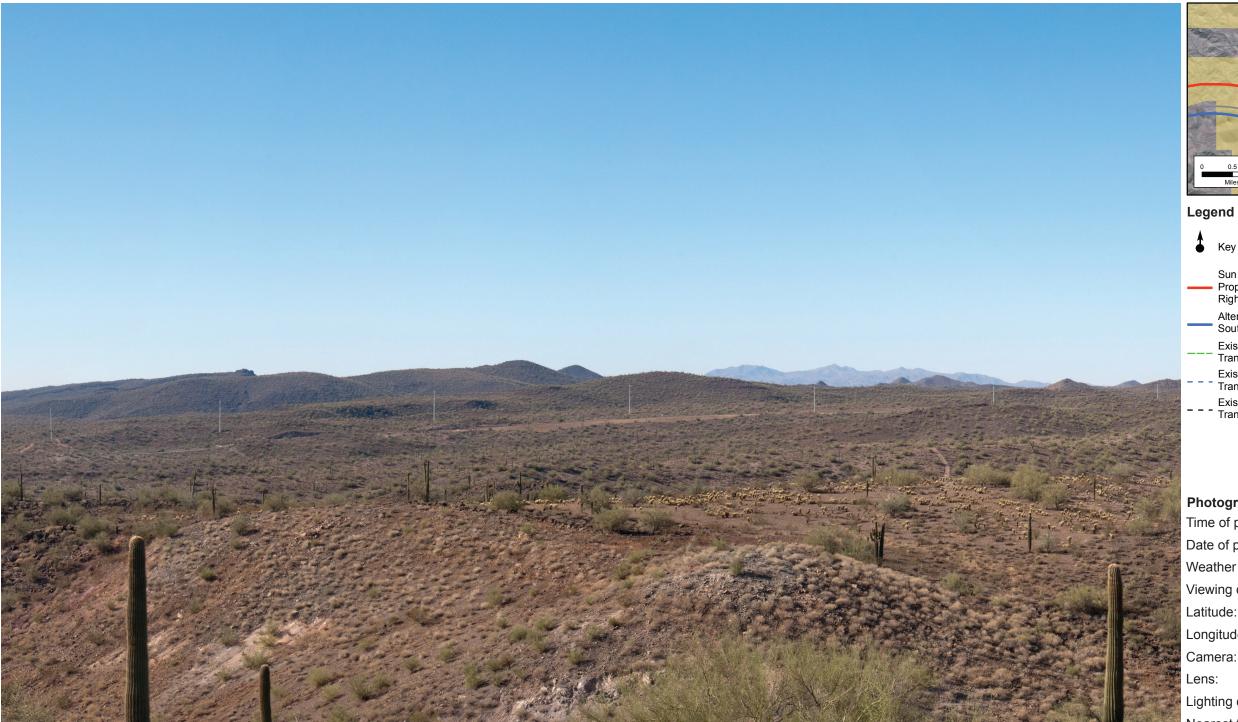
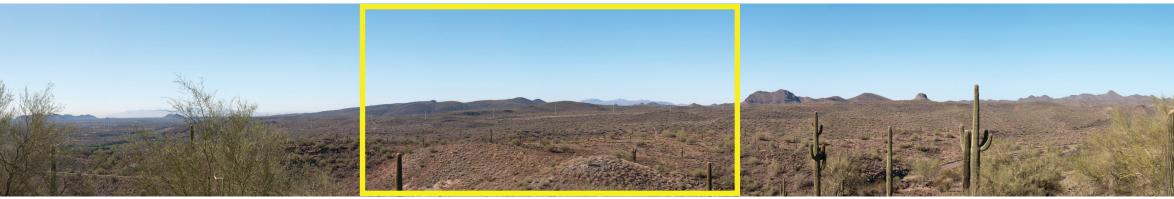
Wash or Stream Sun Valley to Morgan Proposed Action Right-of-Way Regional Park **Surface Land Management** Alternative 2 Bureau of Land Management South of SR 74 Bureau of Reclamation Existing 500kV Transmission Line State Existing 230kV Private Transmission Line Existing 69kV
Transmission Line **Photograph Information** Time of photograph: 9:38 AM 10-19-11 Date of photograph: Weather condition: Clear Viewing direction: Southwest Latitude: 33°50'51.52"N 112°16'49.57"W Longitude: Nikon D700 Camera: 50mm Lens: Lighting condition: Sidelit Nearest tower in view: 1.56 Miles Figure 4.14-20b

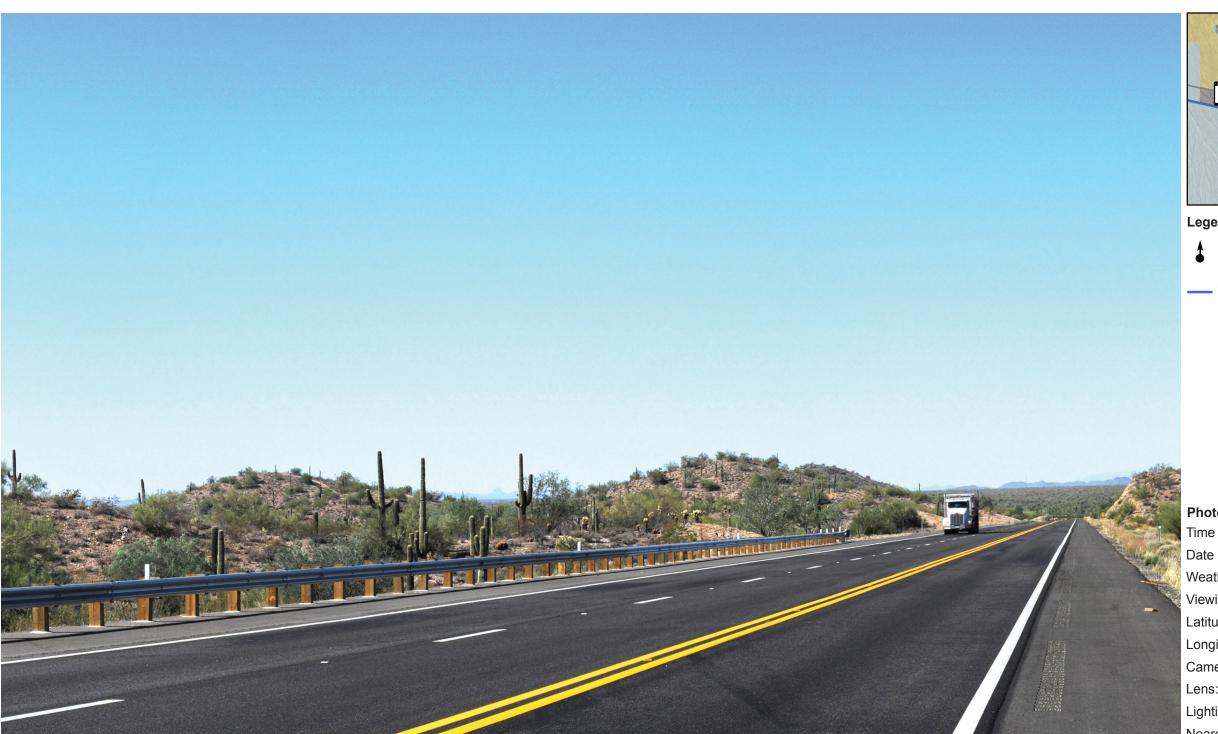
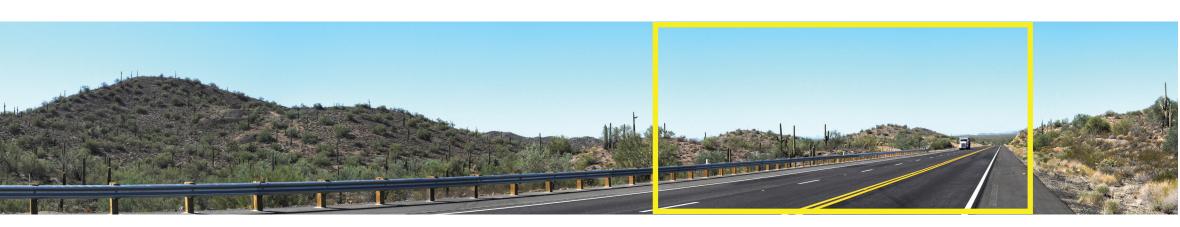
Latitude: 33°49'28.24"N 112°23'18.96"W Longitude: Camera: Nikon D700 50mm Lens: Lighting condition: Sidelit Nearest tower in view: NA

Figure 4.14-23a **Existing Conditions** from Key Observation Point 17d Westbound view from SR 74 looking west

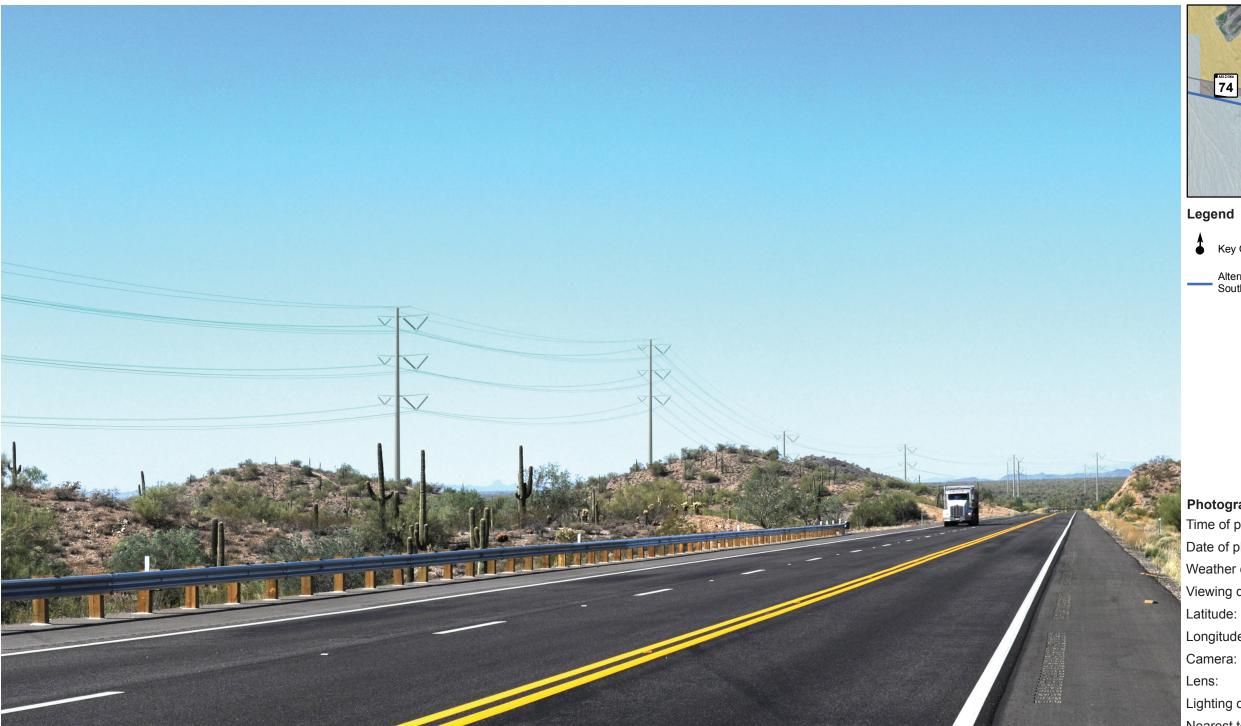
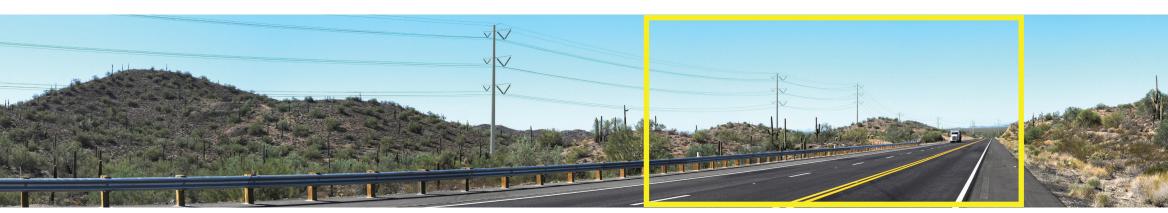
33°49'28.24"N 112°23'18.96"W Longitude: Nikon D700 Camera: 50mm Lens: Lighting condition: Sidelit Nearest tower in view: 0.32 Miles

Figure 4.14-23b Simulation of Alternative 2 from Key Observation Point 17d Westbound view from SR 74 looking west

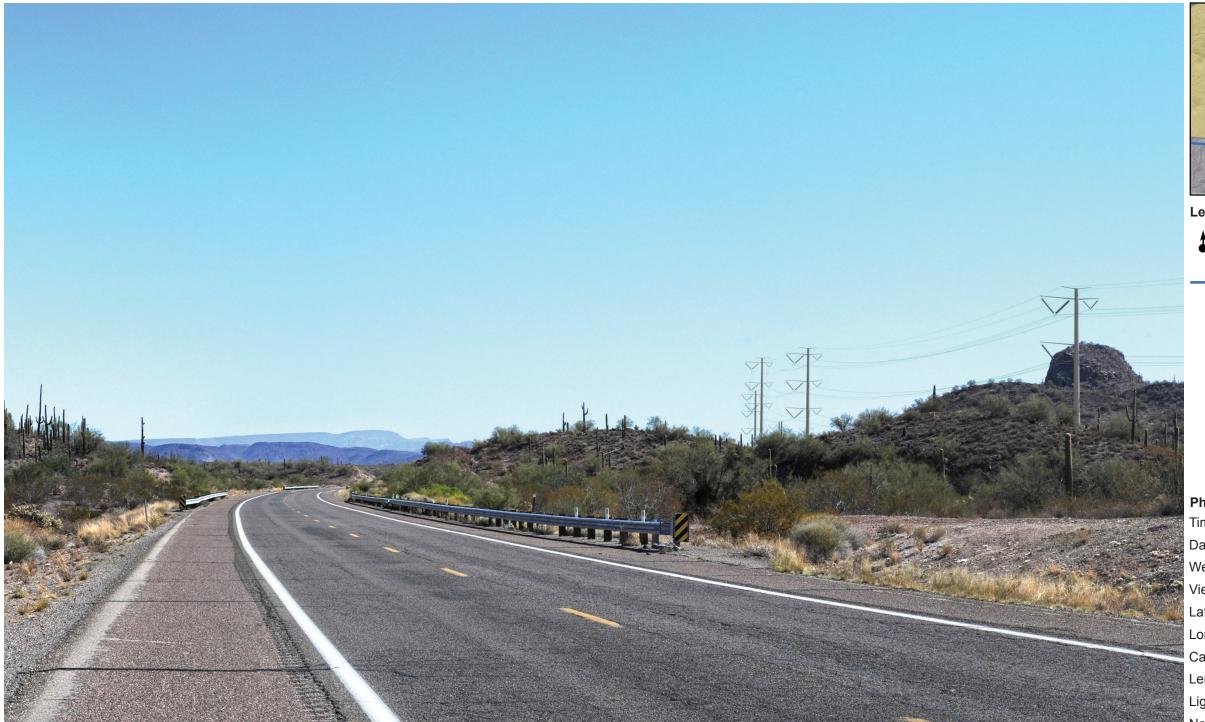
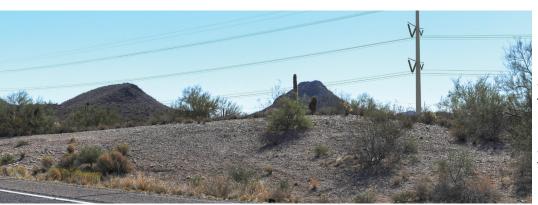
KOP 18d

Nearest tower in view: 0.42 Miles

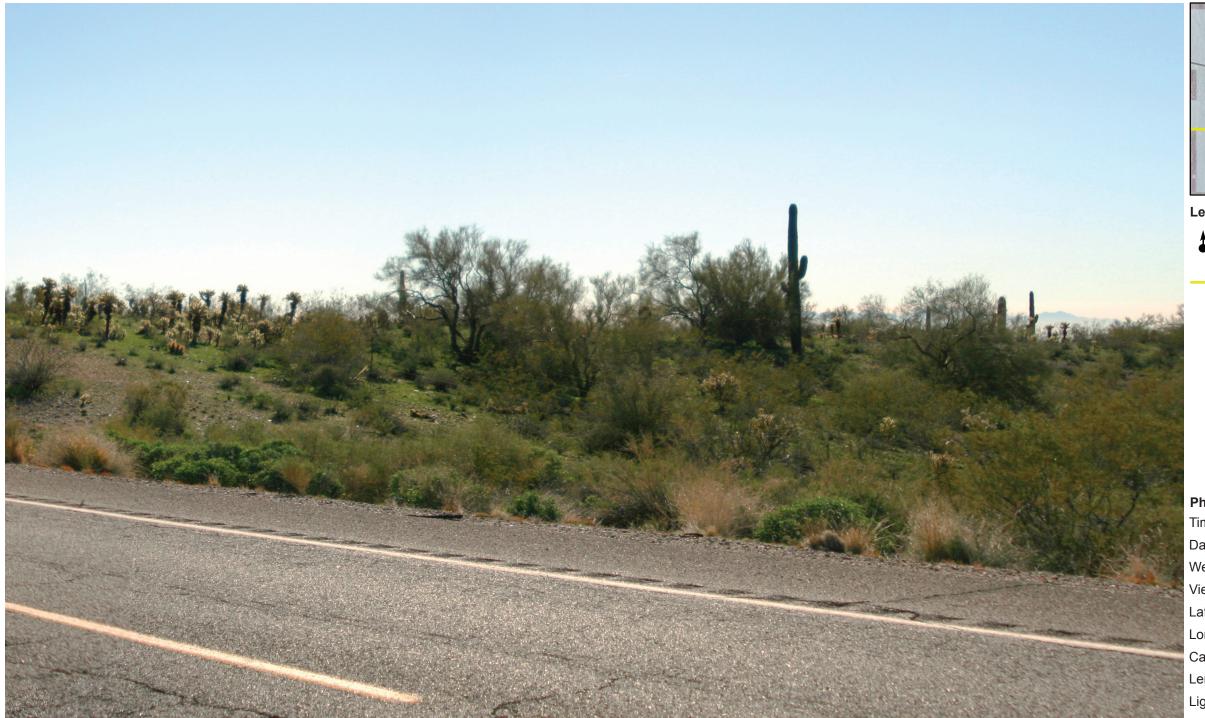
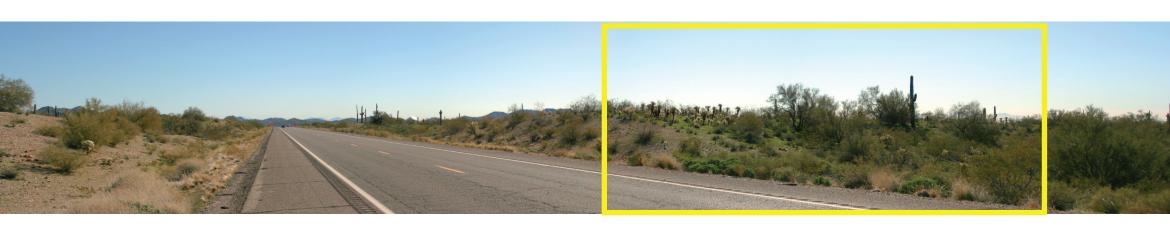
Figure 4.14-26a
Existing Conditions
from Key Observation Point 9
Vicinity of SR 74 and 179th Avenue looking southeast

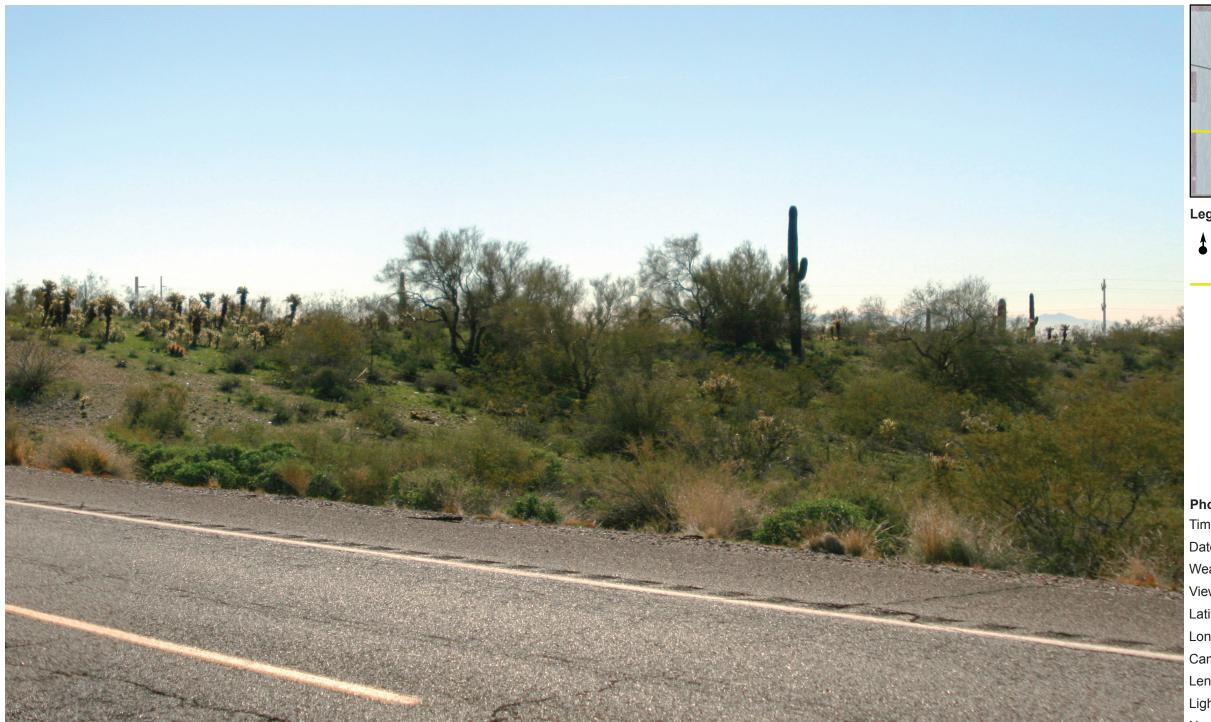
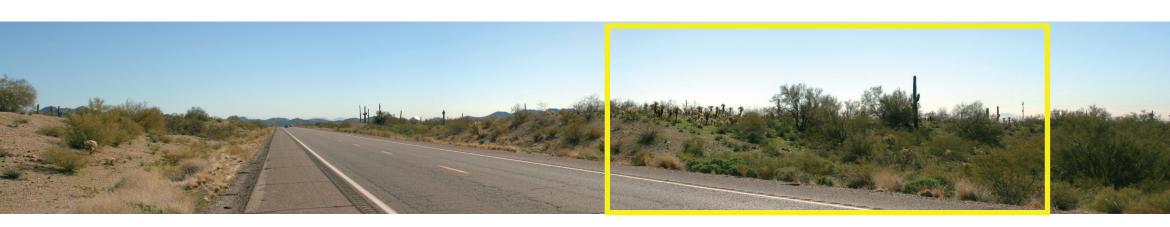
50mm Lens: Lighting condition: Backlit Nearest tower in view: 0.50 Mile

Figure 4.14-26b Simulation of Alternative 3 from Key Observation Point 9 Vicinity of SR 74 and 179th Avenue looking southeast

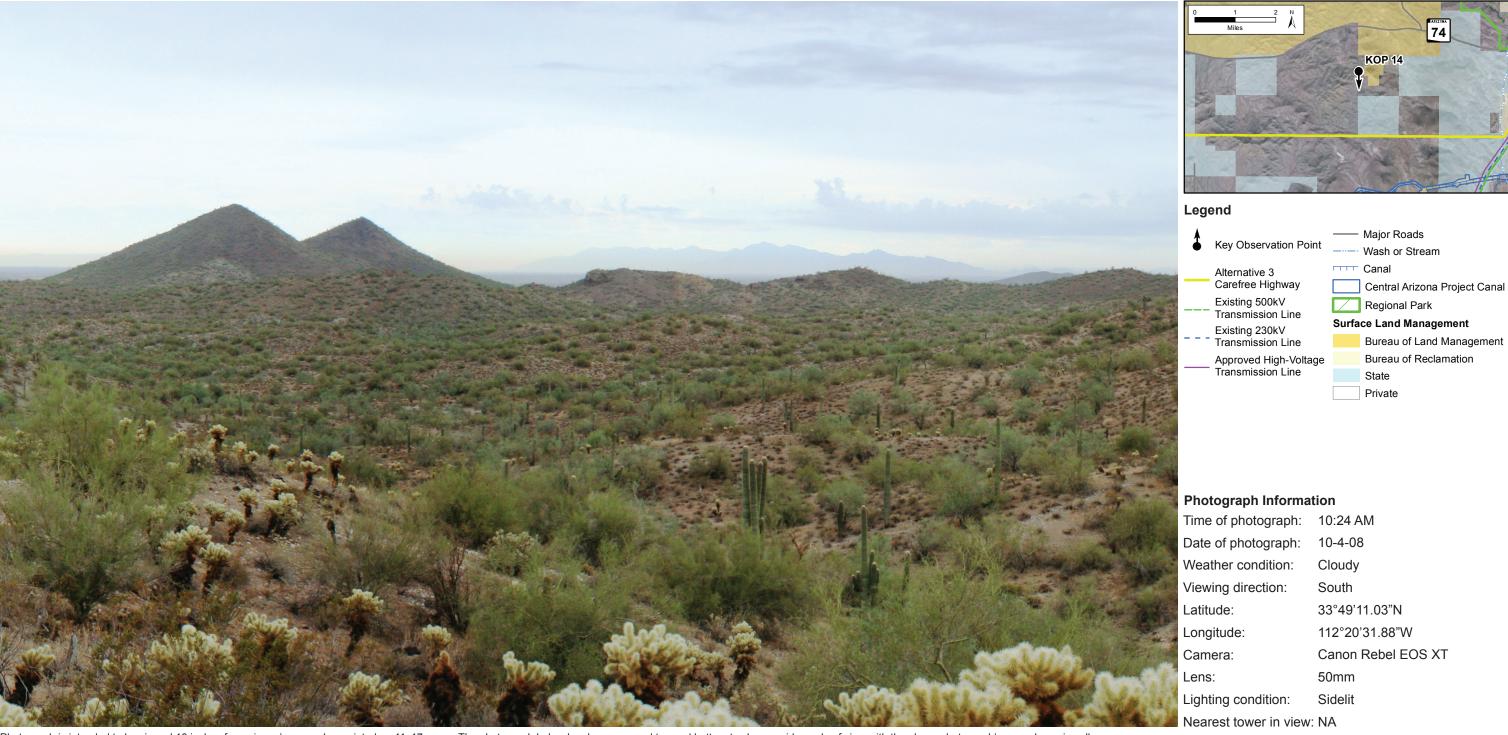
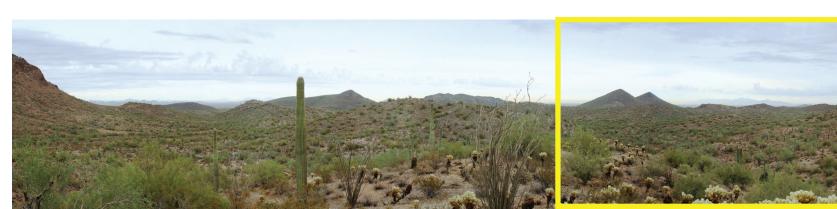
Figure 4.14-27a
Existing Conditions
from Key Observation Point 14
Saddleback Heights property looking south

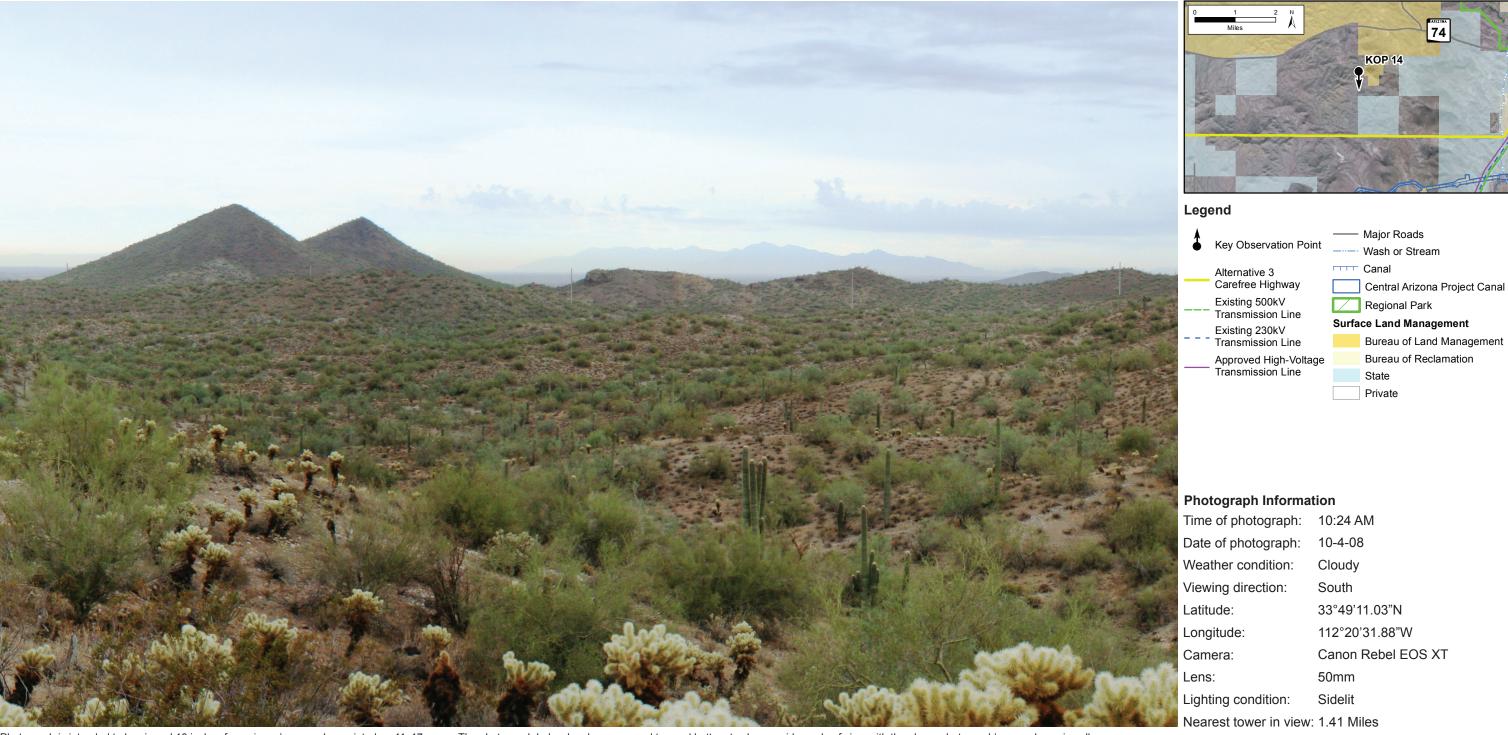
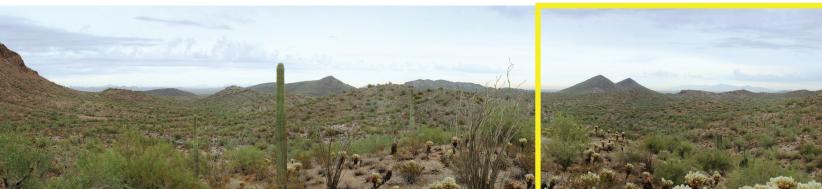
Figure 4.14-27b Simulation of Alternative 3 from Key Observation Point 14 Saddleback Heights property looking south
